DEPARTMENT OF TRANSPORTATION

WELDING INSPECTION REPORT

Resident Engineer: Siegenthaler, Peter **Report No:** WIR-017450 Address: 333 Burma Road **Date Inspected:** 14-Oct-2010

OSM Arrival Time: 700 **Project Name:** SAS Superstructure **OSM Departure Time:** 1530 **Prime Contractor:** American Bridge/Fluor Enterprises, a JV Contractor: American Bridge/Fluor Enterprises, a JV **Location:** Jobsite

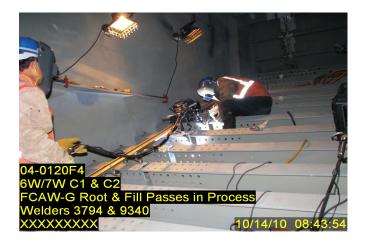
The QAI periodically observed AB/F approved welder Song Tao Huang (ID 3794) assisted by AB/F approved welder Jin Quang Huang (ID 9340) performing semi automatic welding per the Flux Cored Arc Welding (FCAW-G) process in the 3G (vertical) position of root and fill passes on weld ID: C1 & C2. The QAI observed QC Inspector John Pagliero was present to monitor the progress and verify that the welding parameters were within the limits established by the approved Welding Procedure Specification (WPS) identified as ABF-WPS-D1. 5-3042B-1. The QAI observed that the work at this location was in process for the duration of the shift and appeared to be in general compliance with contract documents. See photos below
